Re: Dam Safety Complaint Inspection Report for Lake Dodge Dam (TX05265)
Montgomery County, Texas

DAM SAFETY INSPECTION REPORT

DAM: Lake Dodge Dam

CURRENT INSPECTION DATE: February 23, 2022

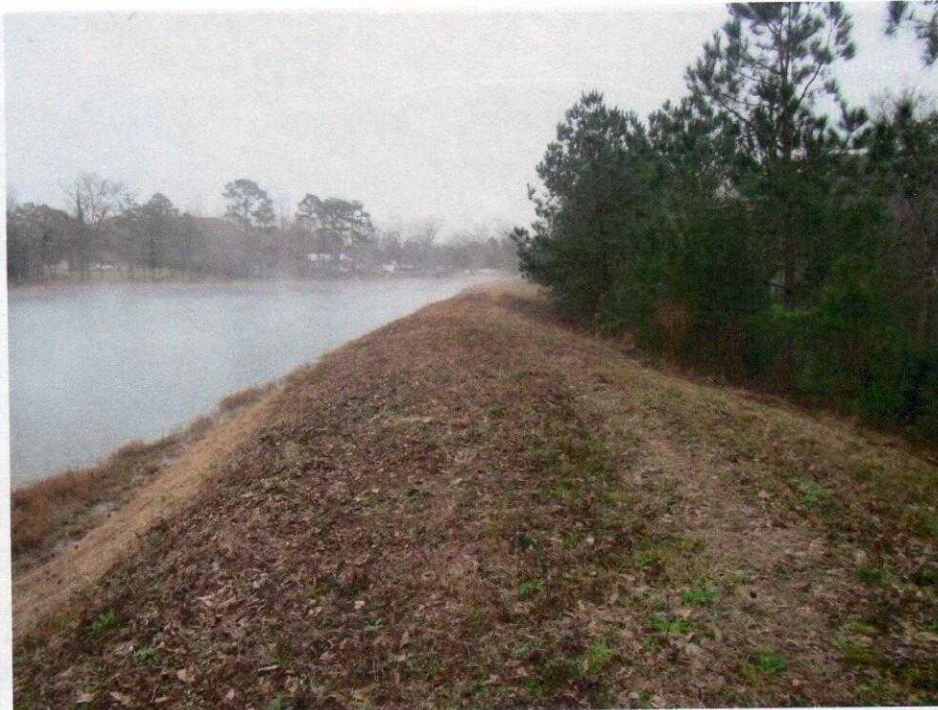
Photo 1: View of the dam crest, from the right side of the dam, facing left (east). Note the fair grass cover and animal trail/foot path.

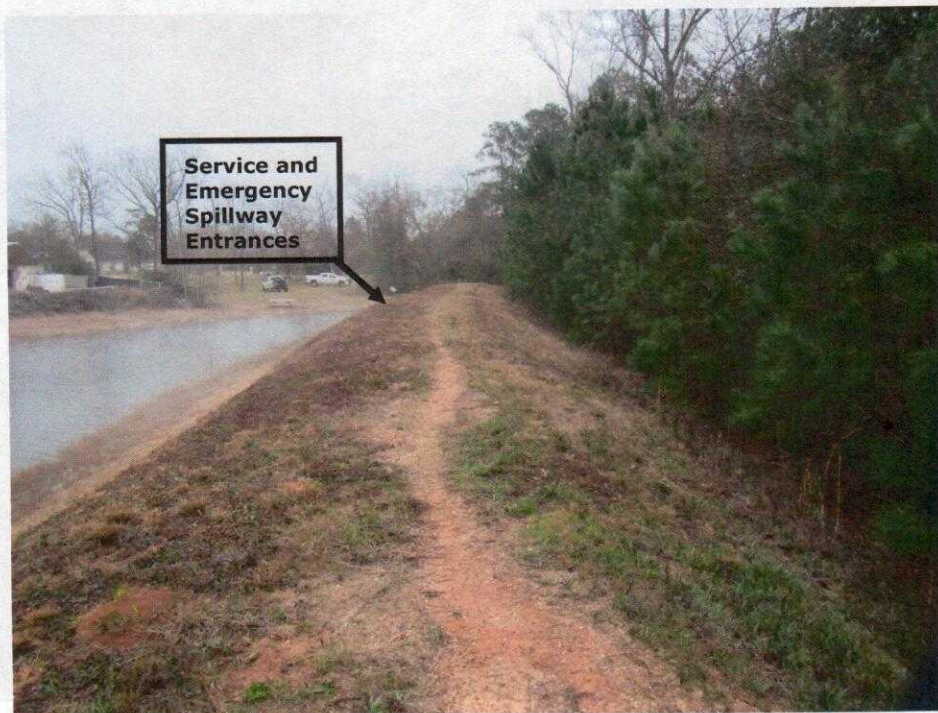
Photo 2: View of the dam crest, from the left/middle side of the dam, facing left (east). Note the fair grass cover and more defined animal trail/foot path compared to the path in photo 1.

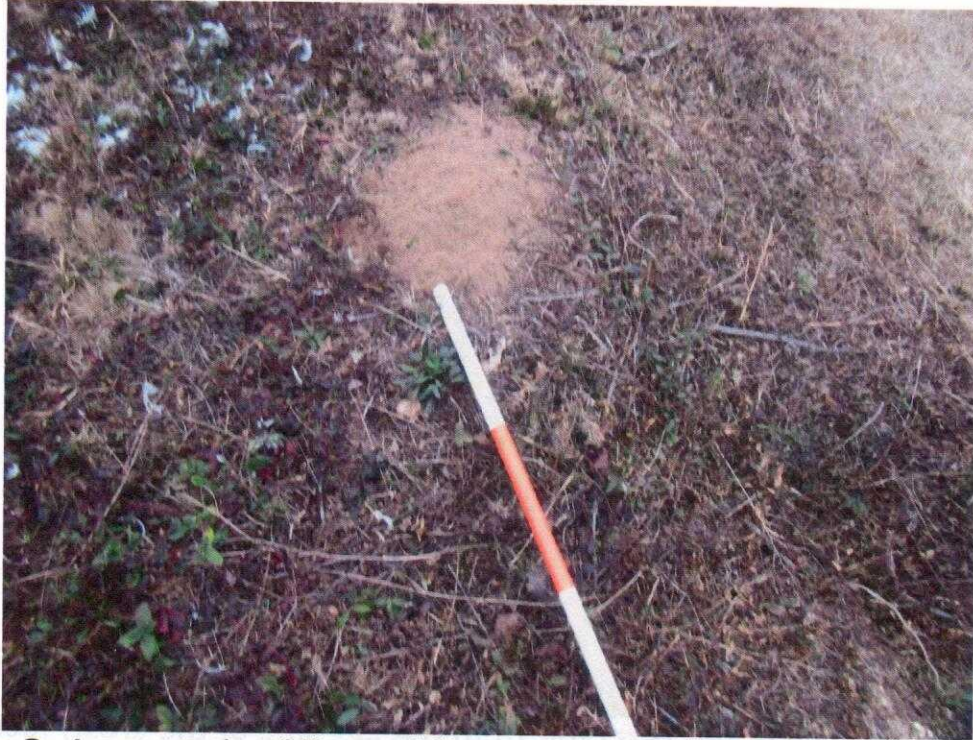
Photo 3: An example of the anthills noted in the dam crest. This example was found on the left side of the dam, facing northwest.

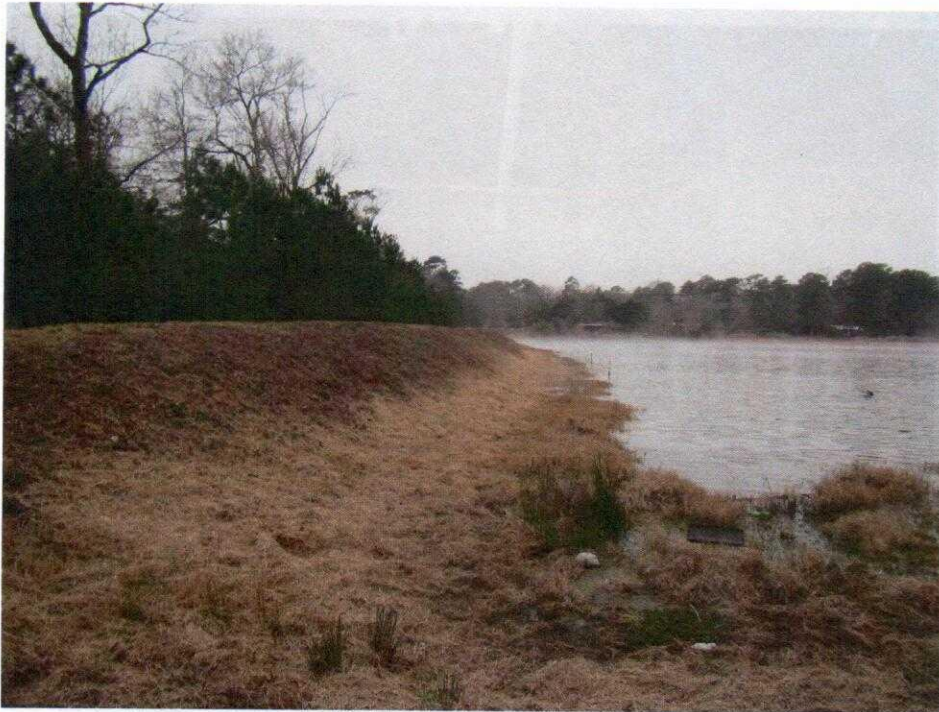
Photo 4: View of the upstream slope, from the left end of the dam, facing right (west). Also note that the upstream slope had been cleared of brush and trees and had a fair grass cover.

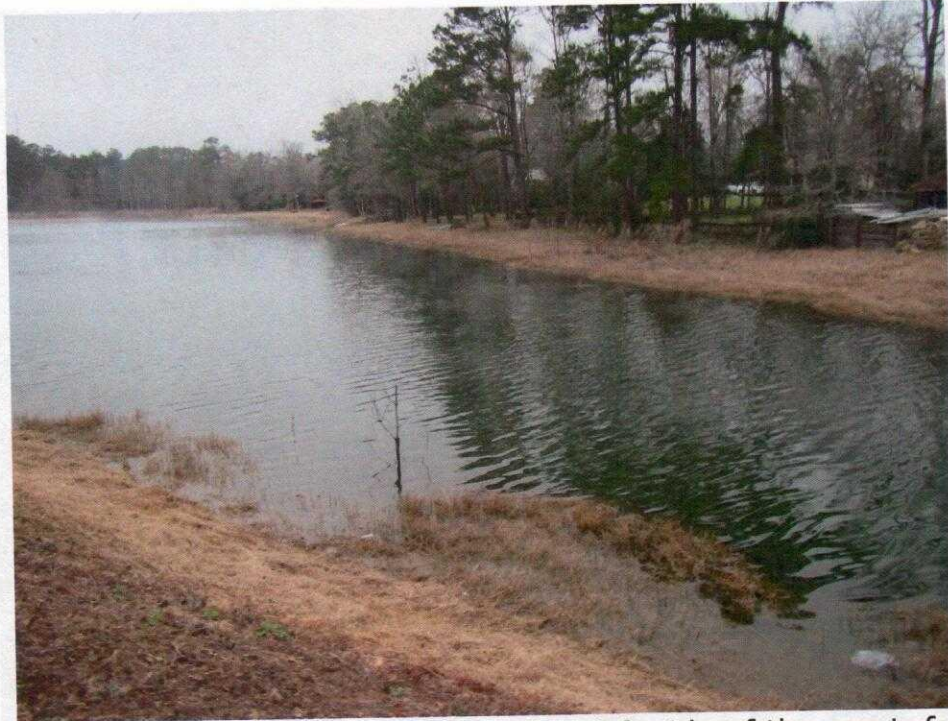
Photo 5: View of the reservoir from the left side of the crest, facing northwest. Note the trees growing near the upstream toe (only the top of the tree is above the water line).

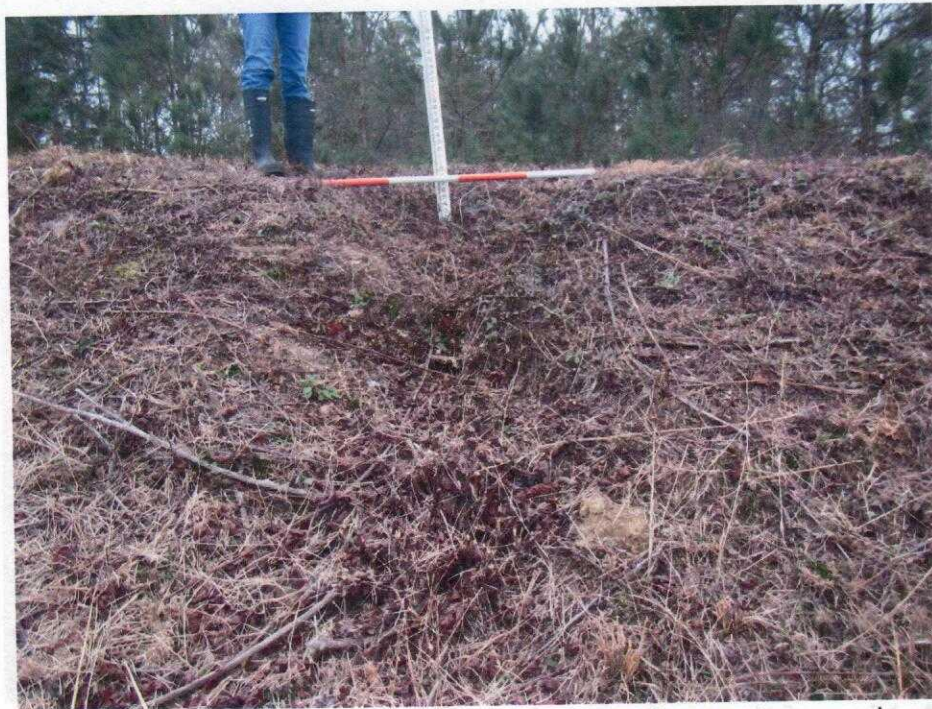
- erosion gullies, up to 4-ft. wide and 0.7-ft. deep, that were found in the upstream slope at the crest shoulder;
- large erosion gullies, up to 4-ft. wide and 3-ft. deep, that were found in the downstream slope;
- a draft emergency action plan (EAP) is not on file for the dam;
- a breach analysis has not been performed for the dam, and;
- the hydraulic adequacy of the dam is unknown.

Photo 6: An example of the erosion gullies in the upstream slope at the crest shoulder. This example was 4-ft. wide and 0.7-ft. deep, on the left side of the dam, facing downstream (south).

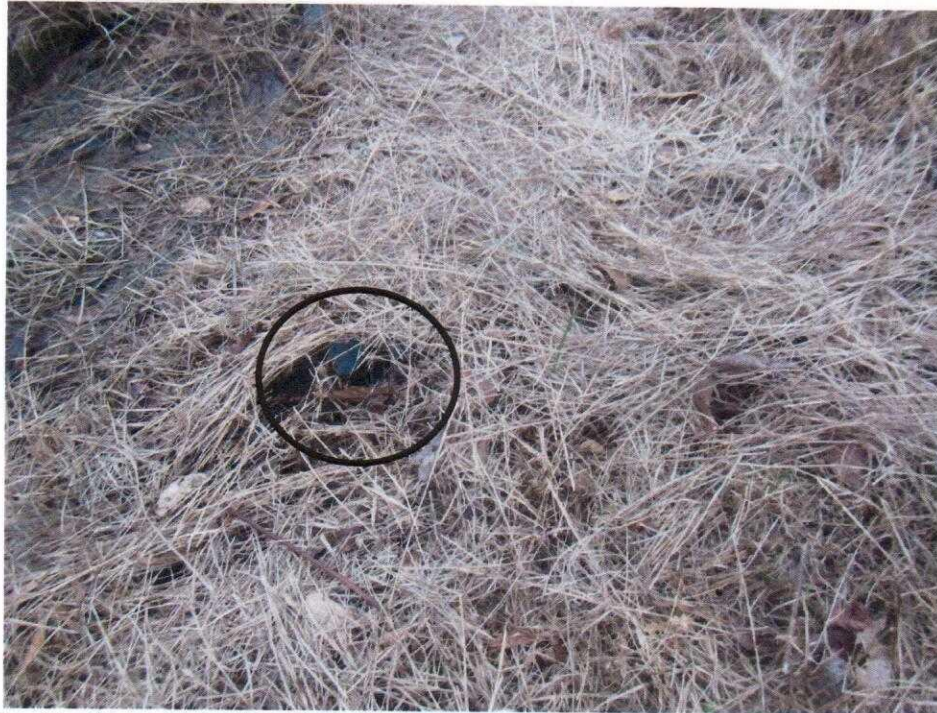
Photo 7: An example of the root balls (circled) and stumps left in the upstream slope. This photo was taken on the right side of the dam, facing northeast.

The root balls left in the upstream slope should be removed and any resulting voids filled with compact clay like material. A good grass cover should be established over these repair areas.

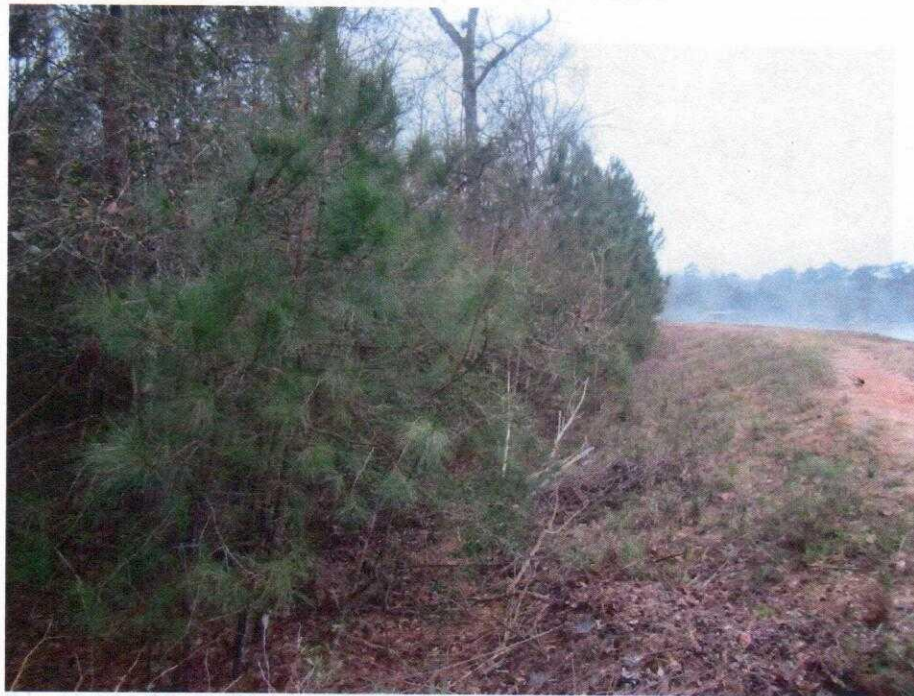
- The 3 H:1 V downstream slope of the earthen embankment was covered with a good grass cover on the upper-third of the slope. The lower two-thirds of the downstream slope and toe were covered with trees, brush, and thorny vines. Most of the lower two-thirds of the downstream slope was obscured from view and could not be inspected. The right end of the downstream toe and an area extending up approximately one-fourth of the slope was fenced off as part of a downstream resident's private property. This area was visually appraised from behind the fence but could not be closely inspected.

Photo 8: View of the downstream slope, from the left end of the dam, facing right (west). Note the thick tree and brush growth along the lower two-thirds of the slope and downstream area.

Trees on the downstream slope, toe, and in the immediate downstream area that are larger than 4 inches in diameter may remain until their natural death, at which time the tree and roots are to be removed, the resulting holes backfilled with properly compacted non-dispersive clay, and a vegetative cover established. Removal of larger trees and backfill repairs should be supervised by a Texas Licensed Professional Engineer (P.E.) with dam experience. Trees provide a cover for burrowing animals, prevent a thorough inspection of the embankment, limit grass growth, provide avenues for seepage as roots decay, and if a large tree is uprooted during heavy winds, the loss of soil around the root mass can lead to a slope failure.

Additionally, larger trees on the downstream slope and along the toe should be pruned up high to facilitate mowing and light penetration for grass growth. Any associated vines found growing around the trees should also be removed.

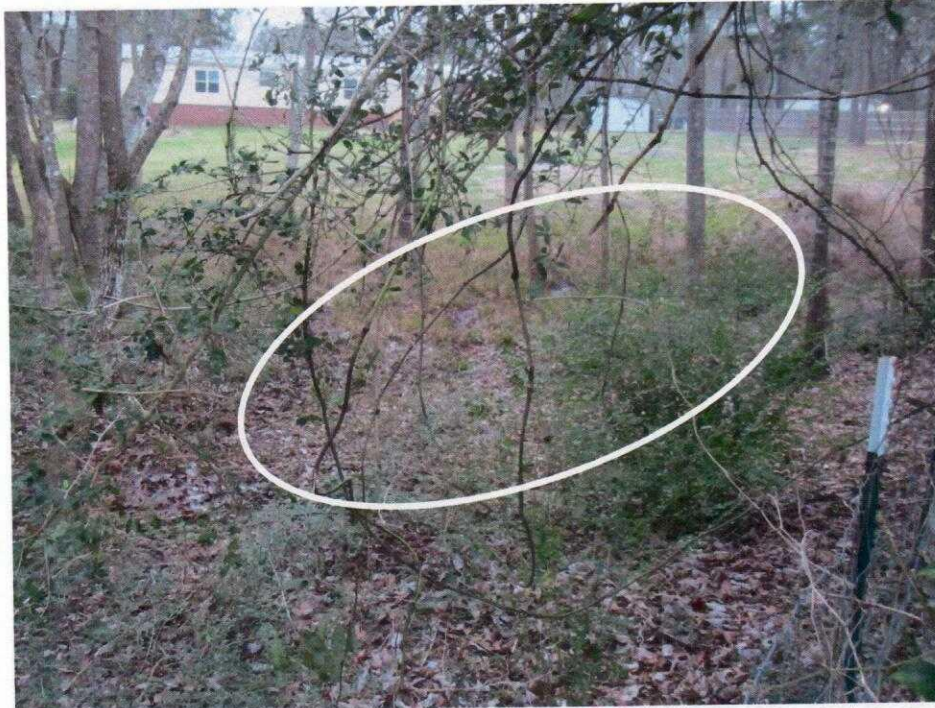
- The area of seepage that triggered the complaint was on the private property, found on the right/middle side of the dam. Since it was fenced off, it could not be closely inspected. Flow from the seepage traveled along the toe to the left for approximately 10-ft. then flowed away from the dam. This appears to be located in the approximate

location that the historic seepage was first noted in the November 2001 inspection report; however, it was undetermined if the seepage in this area had increased or otherwise changed.

Photo 9: View of the seepage area (circled) that triggered the complaint inspection, on the right side of the downstream toe, facing downstream (southwest). Note that the area was fenced off, so the origin of the seepage was not closely inspected.

2. A Texas Licensed Professional Engineer (P.E.) should inspect the seepage sites, and any related underground pockets of water that triggered the complaint inspection, along the right half of the dam behind the fence, all of the historic seepage sites, and the downstream toe area for any new seepage sites. Depending on the results of the inspection, the P.E. should design and oversee any necessary repairs or modifications to any unsafe seepage sites. TCEQ Dam Safety should receive a copy of the P.E.'s inspection report and findings/recommendations. Also, TCEQ Dam Safety must review and approve any and all related construction plans and technical specifications before construction may begin.

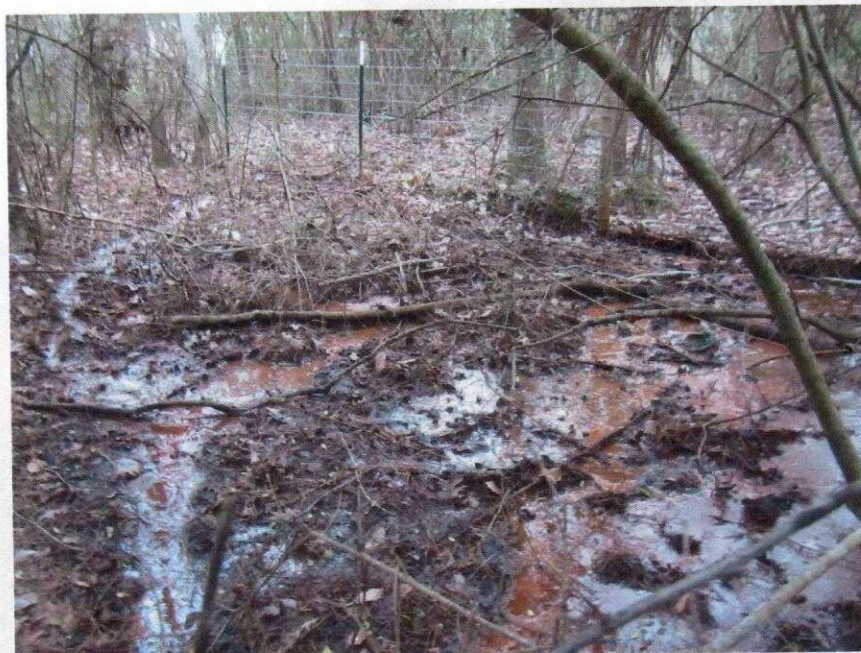
Photo 10: View of the flow from the seepage noted in photo 9. This photo was taken from the right side of the dam at the edge of the fence line, facing the upstream direction of the seepage flow (southwest).

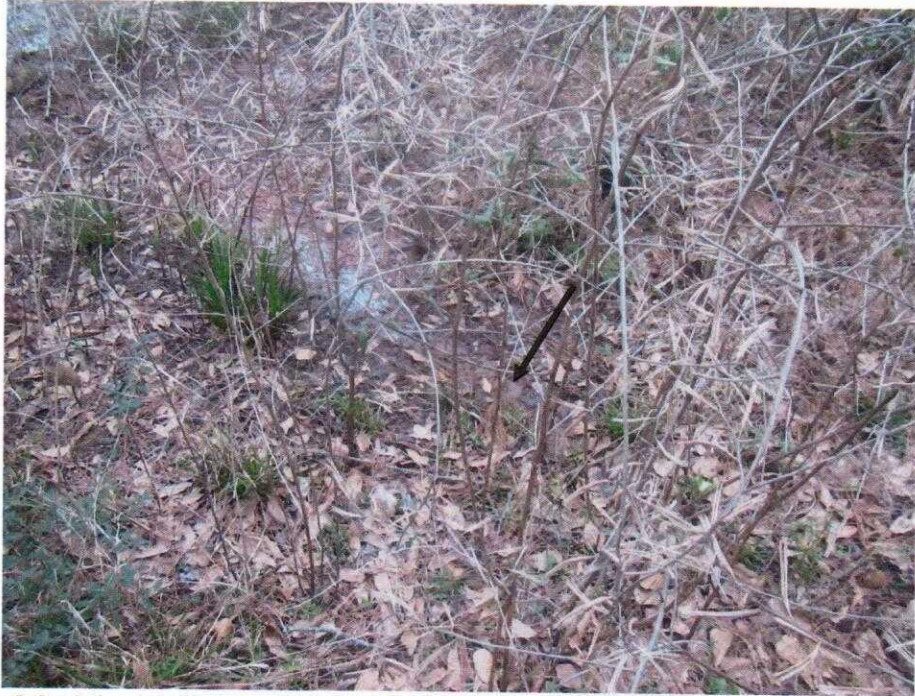
- Holes (cause unknown) were found in the downstream slope. The largest one measured was 4-ft. deep and 3-ft. in diameter.
- Two additional areas of seepage/standing water indicated by filamented iron ochre were found along the downstream toe near the right/middle side of the dam. One seepage site was found along the toe and the second was approximately 3-ft. up the downstream slope from the downstream toe. No visible flow or suspended fines/sediment were found.

Photo 11: View of the seepage (arrow) emerging from the downstream slope, approximately 3-ft. up the downstream slope from the toe. This photo was taken on the right side of the downstream slope, facing downstream (southwest).

4. The two areas of seepage in the downstream toe area and on the downstream toe should be routinely monitored. Also, the areas of historic seepage that may have been obscured from view should also be routinely monitored, even if they could not be found during this inspection. The normal amount should be estimated, and the seepage monitored at least monthly for any increase, especially if there is no corresponding rise in reservoir elevation. Recording seepage rates and corresponding reservoir level observations in a maintenance log will help identify potentially critical areas where water may be seeping through the embankment or foundation; extra care should be taken to detect seepage when reservoir levels are high. The downstream toe area should also be routinely monitored for new areas of seepage, and their conditions, as listed previously, recorded.

If the historic seepage locations move (or emerge) high up on the embankment and/or historic seepage flowrates should increase drastically or include suspended soil (fines) or boils, then it is possible/likely that a piping condition exists and your P.E., as well as TCEQ Dam Safety, should be contacted immediately. The reservoir may need to be lowered or drained to prevent an emergency situation from developing.

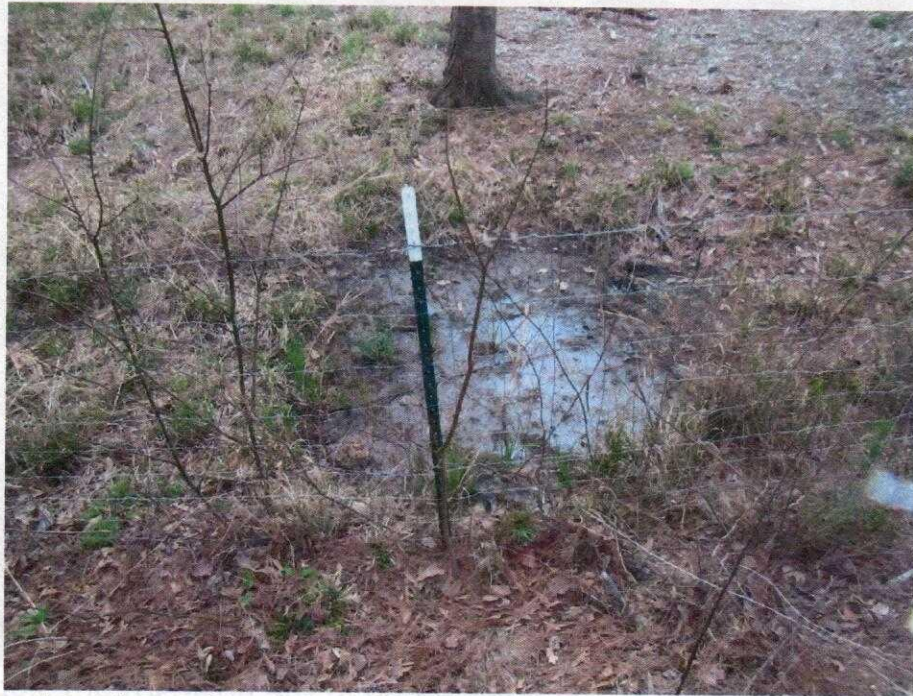
Photo 12: View of an area of standing water, on the right side of the downstream toe, facing downstream (south).

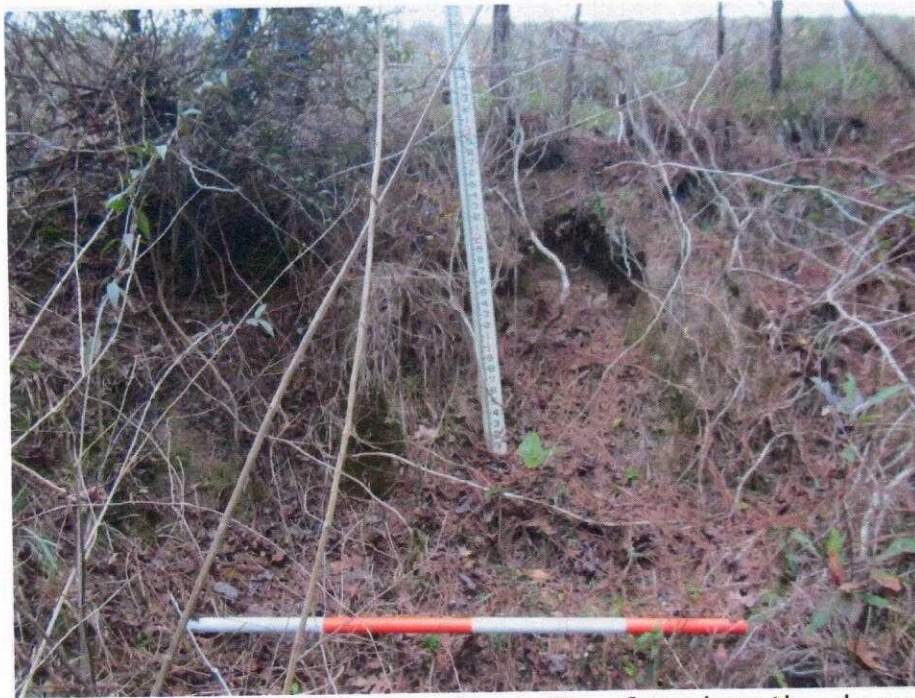
- Several large erosion gullies were noted in the downstream slope below the tree line on the right side of the dam, but the vegetation growth prevented an accurate measurement. The closest measurement taken was 4-ft. wide and 3-ft. deep. The left side of the downstream slope could not be inspected for erosion because of the overgrown vegetation.

Photo 13: An example of the erosion gullies found on the downstream slope. This example measured approximately 4-ft. wide and 3-ft. deep. This example was found near the middle of the dam, facing upstream (north).

3. Once the downstream slope, toe and immediate downstream area are cleared of excessive tree and brush growth, the downstream slope and toe should be inspected by a P.E. for signs of structural instability or other deficiencies hidden during the inspection. Depending on the results of the inspection, the P.E. should design and oversee any necessary repairs or modifications to any locations with signs of structural instability. The P.E. should also oversee repairs to the erosion gullies on the lower two-thirds of the downstream slope. TCEQ

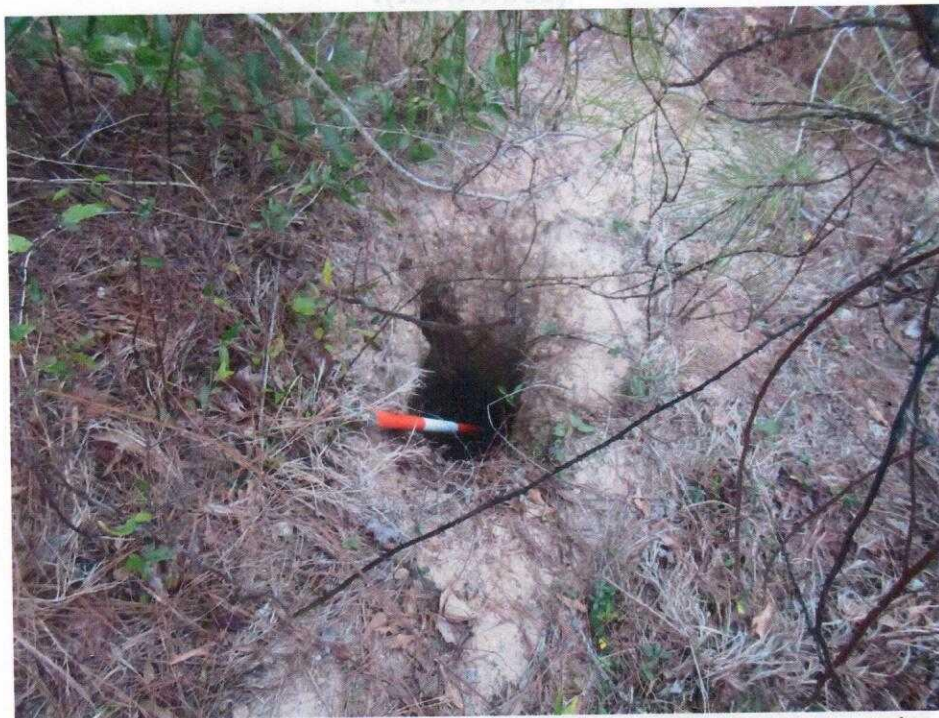
Photo 14: An example of the holes found in the downstream slope. This example measured to be 3-ft. wide and 4-ft. deep. This photo was taken on the right/middle side of the dam, facing upstream (north).

9. The noted holes should be backfilled with properly compacted non-dispersive clay, and a vegetative cover should be established. Burrowing activity can create flow paths and can otherwise weaken the integrity of the embankment. Assistance in removing nuisance animals can be obtained from the Texas Wildlife Services Program. Burrowing animals should be discouraged from inhabiting the dam.

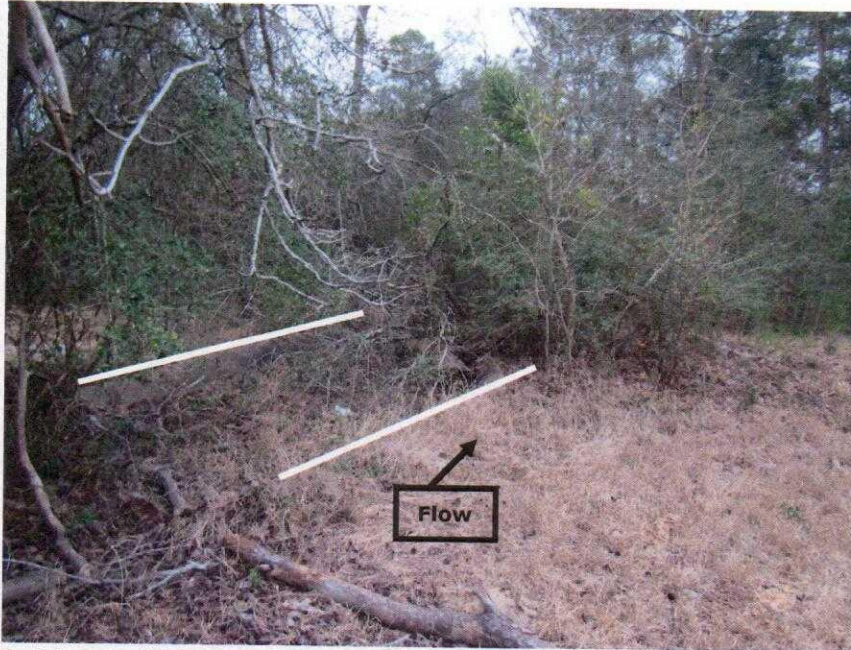
- The service spillway is located at the left end of the dam.
- The service spillway consists of a concrete channel 8-ft. wide and 1-ft. deep that discharges into a natural channel.
- Most of the service spillway was obscured due to tree and brush growth. The visible portions of the service spillway had trees, brush, leafy debris, and downed trees within the channel that could impede flow away from the dam.
- The service spillway was found to be in poor condition due to the debris and vegetative growth obstructing the channel.

Photo 15: View of the service spillway channel entrance (lines), from its right/upstream corner, facing downstream (southeast). Note that the channel is almost obscured by brush, trees, and debris.

For any larger/mature trees immediately adjacent to the concrete service spillway channel, it may be preferred to cut the tree and leave the stump in place, if removal of the root ball would cause damage/movement to the concrete channel. Any remaining stumps should be treated with a sealant to inhibit/prolong decay. Once cleared, a P.E. should inspect the spillways for any defects that may have been hidden by the trees and overgrown vegetation. Depending on the results of the inspection, the P.E. should design and oversee any necessary repairs or modifications to the spillway(s). TCEQ Dam Safety must review and approve any and all construction plans and technical specifications before construction may begin.

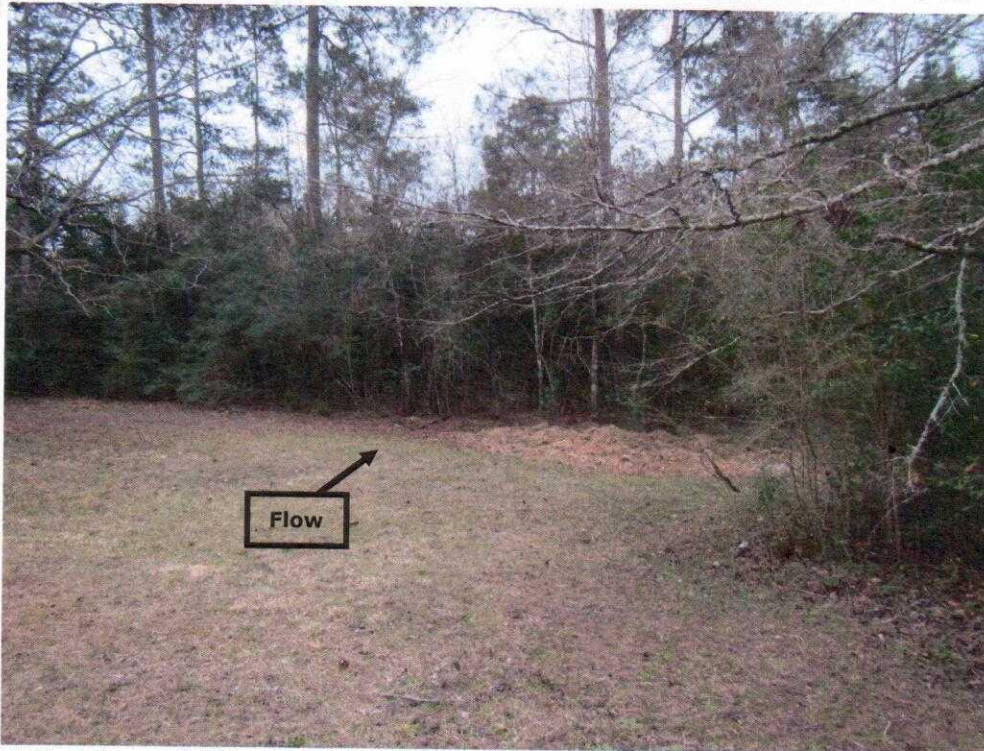
- The emergency spillway is an undefined low area located immediately to the left of the service spillway.
- Historically, it has been listed as being 15-ft. wide and had an elevation 2-ft. below the top of dam elevation.
- A review of 2017 light detection and ranging (LiDAR) elevation data indicated that the low area is approximately 51-ft. wide and between 372.5-ft.-msl. and 372.9-ft.-msl (ranges between 1.4-ft and 1.8-ft below top of dam). The area is undefined, so measurements are general approximations.
- The emergency spillway was overgrown with brush and trees. It could not be closely inspected.

- The emergency spillway was found to be in poor condition due to the overgrown condition obstructing the channel and limiting the inspection.

Photo 16: View of the emergency spillway entrance, from the left/upstream corner of the service spillway chute, facing downstream (southeast). Note that the channel is lined with thick tree growth that would impede flow.

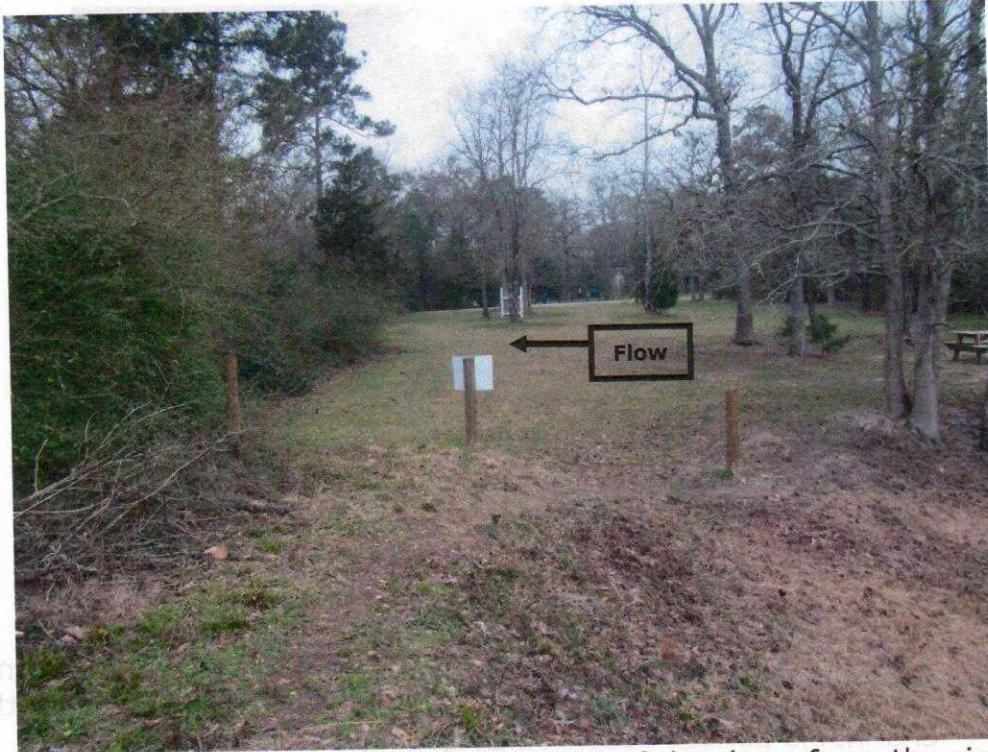
- The inspectors noted a low area to the right of the dam. A review of the 2017 LiDAR data indicated that this natural low area has an effective elevation of 373.6-ft.-msl (0.7-ft below top of dam) that widens from 8-ft. to 47.6-ft.
- Since this area does not appear to have appreciable flow capacity, it is inadequate to function as a spillway. Therefore, it is not considered to affect the hydraulic capacity of the dam to a significant degree.
- However, two houses are within the direction of flow from this area and have foundation elevations below the effective top of dam elevation. Therefore, these houses may be impacted should even low amounts of flow pass through this low area.

Photo 17: View of the low area to the right of the dam, from the right end of the crest, facing right (west). Note the trees in the immediate channel.
